Inspection Report Minerals Regulatory Program

Mine Name: Road Canyon (proposed) Permit Number:			5
Operator Name: Robert Steele	Inspection Date: August 14, 2015 Time: mid-day		
Inspector(s): Peter Brinton			
Other Participants: none	Mine Status:	Proposed	
Elements of Inspection	Evaluated	Comment	Enforcement
 Permits, Revisions, Transfer, Bonds Public Safety (shafts, adits, trash, signs, highwalls) Protection of Drainages / Erosion Control Deleterious Material Roads (maintenance, surfacing, dust control, safety) Reclamation Backfilling/Grading (trenches, pits, roads, highwalls, shafts, drill holes) Soils Revegetation Other 			
Permit fee: Current Rond Renewal Date: N/A	P	and Amount	· none

Inspection Purpose: Determine whether site has been disturbed prior to file closure

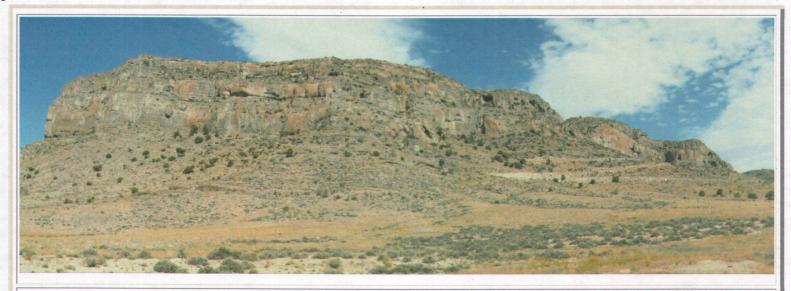
View of the general site without new disturbance, looking roughly north-northwest. Note the old switchbacks from a previous project to the right. Stitched.

Conclusions and Recommendations: No disturbance associated with this proposed Notice was discovered. No small mine permit was ever issued, and no reclamation surety exists. Considering the time elapsed without permitting or mining activity, it is recommended that the file be closed, and the operator notified that new permitting with the Division is needed prior to future mining or exploration. Aggressive weed control may be needed in the event of future surface disturbing activities.

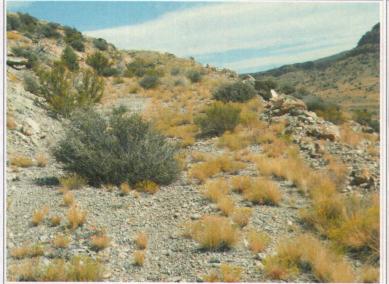
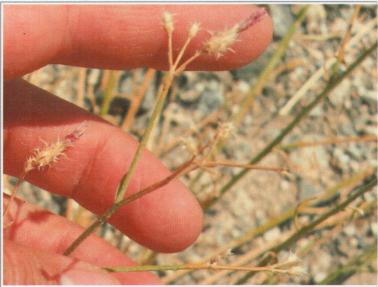
An old cut-fill road with a few switchbacks was found in the immediate vicinity of the proposed operation. Incomplete Division correspondence indicates this disturbance is (or was) bonded with SITLA. The disturbance pre-dates Mr. Steele's project, and may have been associated with Echo Bay Exploration Inc.'s exploration project in the 1980s. A solitary squarrose knapweed plant (a noxious weed) was discovered on the old road, which has largely and naturally revegetated with natives.

Squarrose knapweed flower and plant.
